Sunk Within Seconds

The disappearance of a Great Lakes fishing vessel.

by MS. BETTY LYNN SPRINKLE
Special Correspondent to *Proceedings*

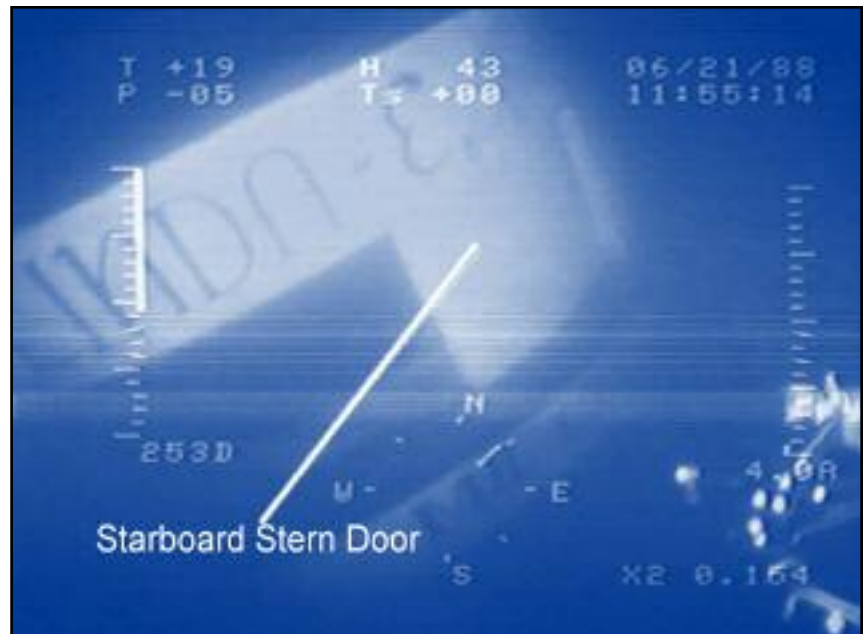
tom of Lake Michigan in 260 feet of water, upright, partially imbedded into the lake bottom with an approximate 20 degree heel to port (Figure 1). The vessel is 0.2 miles west of the northern gang of nets identified as being set by the crew. The closest point of land is the Wisconsin shoreline, seven miles to the west. The service door on the aft port side of the vessel was found open. A small tangle of fishing nets extended just outside this door. Two of the three stern doors on the vessel were found open. The door that slides open to the port side of the vessel was fully open. One of the two doors that slide open to the starboard side of the boat was fully open and the other was partially open. The spreader bar over which nets are normally set could be seen as could a small amount of nets through the stern door. All other doors on the vessel were closed (Figure 2).

Figure 2: View of the starboard stern door.

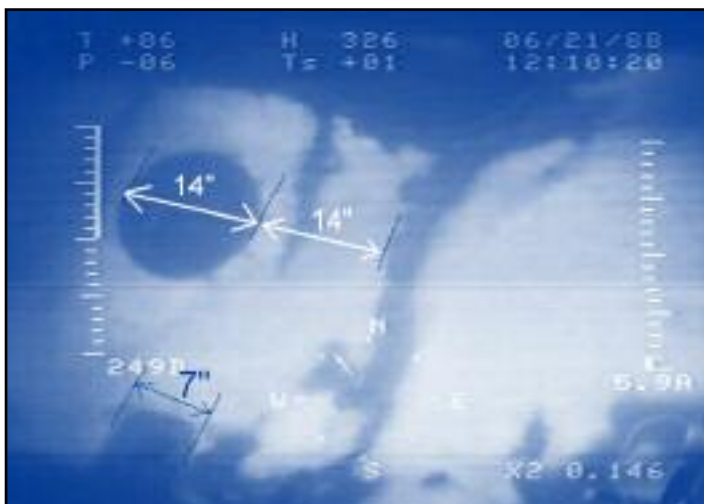
Figure 3: Damage to the vessel.

There was significant damage on the starboard quarter of the *Linda E*, along the side of the vessel from the forward end of the deckhouse aft, almost exclusively above the rub rail.

A wedge-shaped inset centered 14 inches forward of the aft, starboard portlight extended six feet vertically down from the top of the lower deckhouse to just below the rub rail (Figure 3). This inset was several feet wide near the upper deck and a few inches wide near the rub rail. The upper deck was crushed downward near the center of this inset. The deck was torn upward a few feet aft of the center of this inset.

The aft starboard portlight had several fractures but

was not broken open. The lower deckhouse portlights on the starboard side were broken, their frames crushed. None of the other portlights on the vessel appeared to be damaged.

Appendages on the vessel were tilted in different directions. Those in front of the main inset bent forward and to port. Those behind the main inset are bent aft and to port. A number of appendages near the damaged area showed no visible signs of contact. There was no significant damage to the port side of the *Linda E*. Although the lake bottom obscured much of the bottom of the vessel, the visible portion of the hull beneath the rub rail showed little damage beyond a few superficial scratches. There appeared to be no significant damage to any other part of the vessel. There was no visible indication of fire on the vessel and no physical remains of the three missing crewmembers were found during the June 21, 2000 ROV dive.

The evidence suggests that the *Linda E* collided with the *Michigan/Great Lakes* barge. The MSC's comparison of the *Linda E*'s damage profile and the bow geometry of the barge determined that the most likely angle of heel that the *Linda E* would have experienced, had they collided, to be approximately 51 degrees to port. With a 51 degree angle of heel, the entire port side of the *Linda E* would have been submerged. If both the port service door and part of the stern door were open, the MSC estimated that it would take about two seconds to exceed the *Linda E*'s buoyancy and flood the vessel. This would explain the lack of distress signals or attempts to abandon ship.

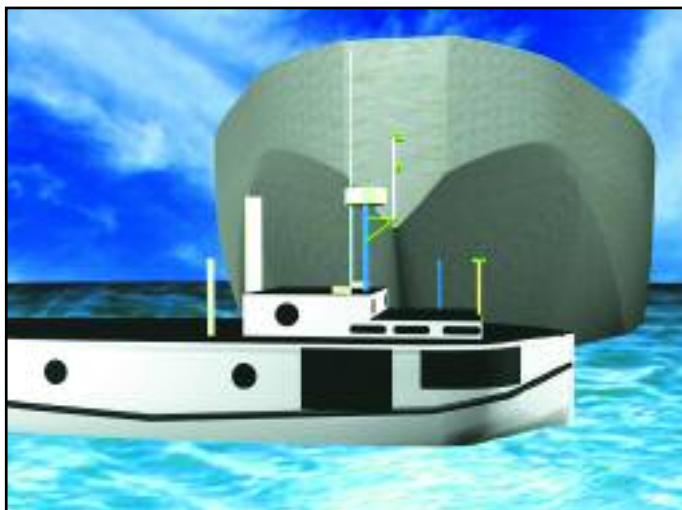
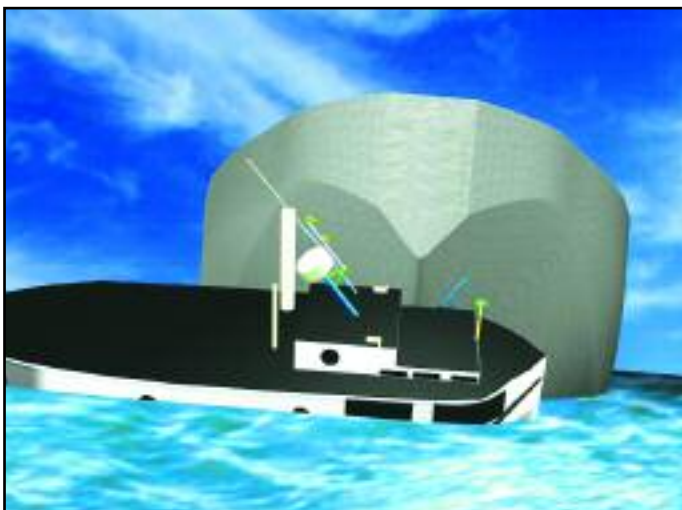
Figures 4 and 5: Graphic analysis, illustrating how the accident may have taken place. Courtesy Marine Safety Center.

It is possible that the crew aboard the ITB neither felt, heard, nor observed the collision with the *Linda E* (Figures 4 and 5). Marks and damage to the barge suggested the collision was brief and light. Even if the collision were more severe, the resulting change in velocity of the barge would not have been detected by any crew members. Noise from generators and activity on the barge may have prevented hearing any sound of a collision and the *Linda E* most likely sank so quickly that it did not pass far enough aft to be seen by anyone on deck of the barge or in the pilothouse of the tug.
